Classification	Number	Date	Contact
AFTERSALES	AS 042/01 Pg 1/2	24/8/01	MITCH KENNY

PRODUCT	SUBJECT	CLASSIFICATION	PRIORITY	REFERENCE
MOTOR CYCLE	CLUTCH	ENGINE	B	MK

CG125W - CLUTCH NOISE AND JUDDER WHEN PULLING AWAY

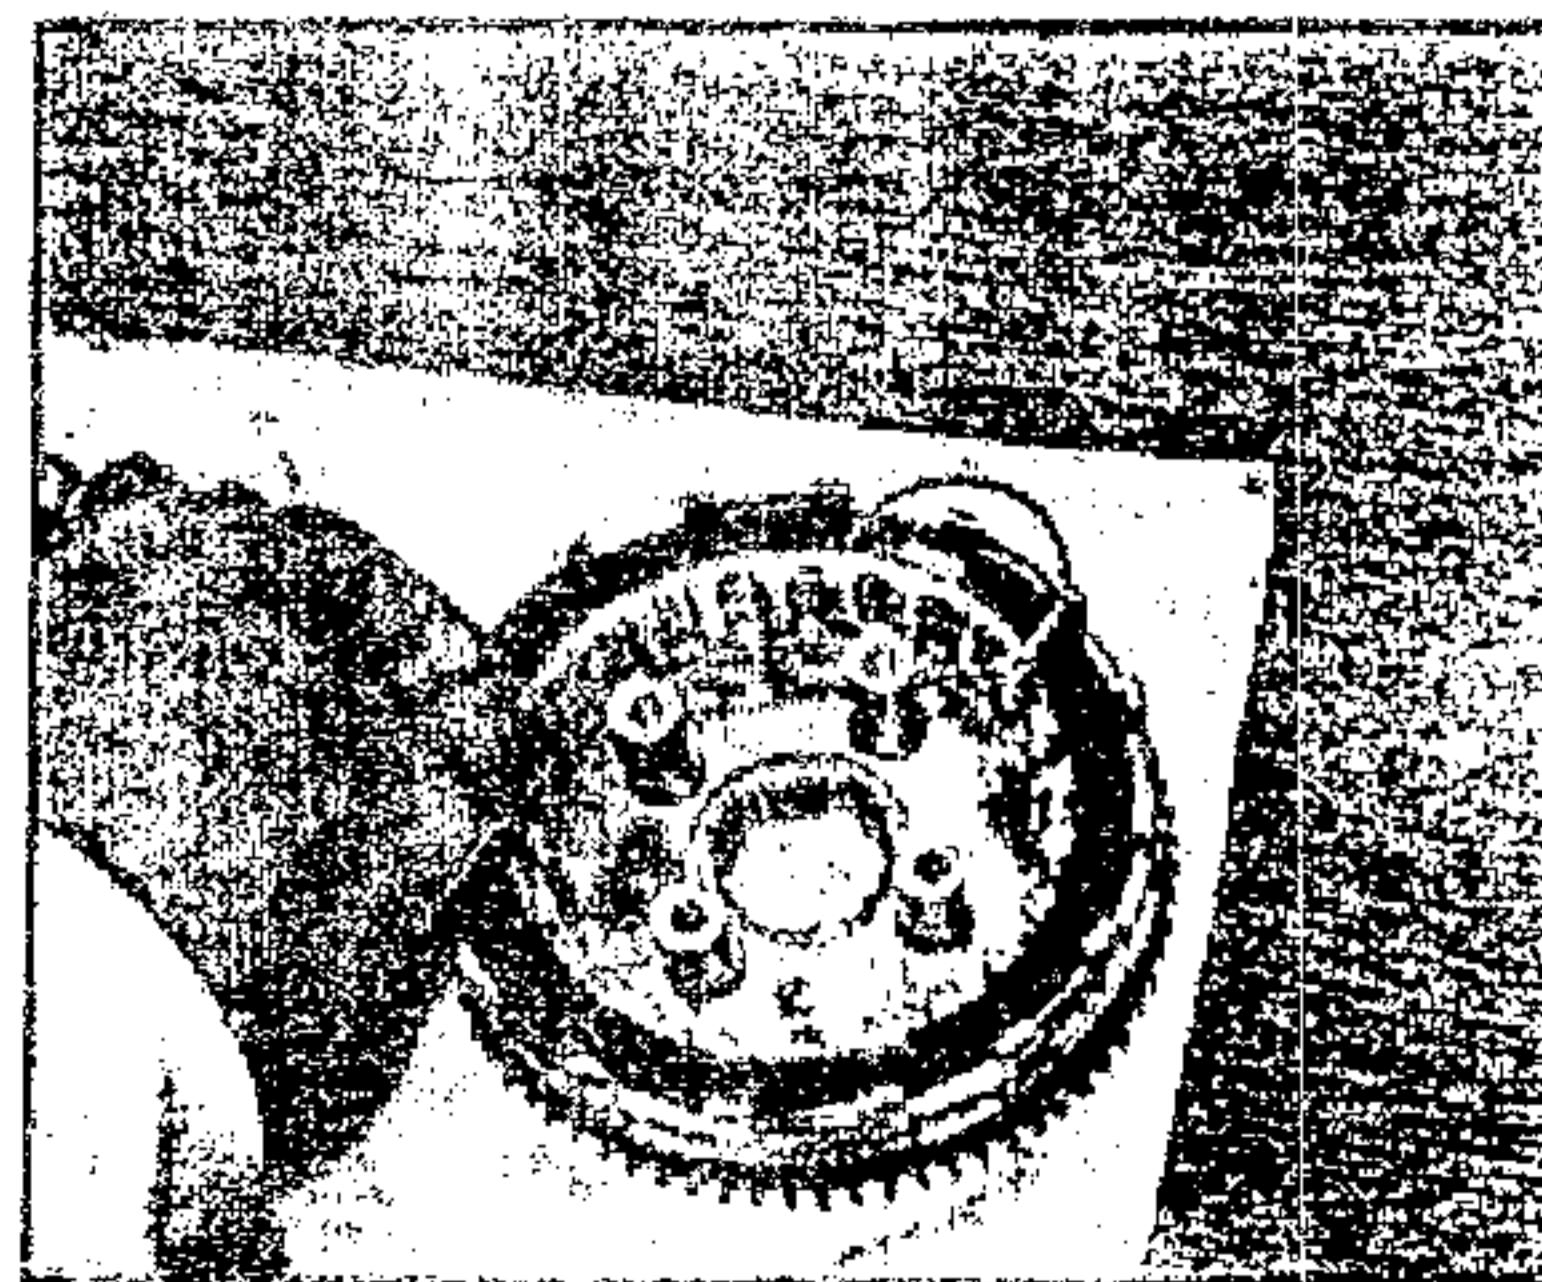
In conjunction with the installation of the new judder spring, a judder spring seat and friction disc are also required. Upon customer complaint, please order and install the counter measure parts listed on page 2 of this bulletin, following the instructions below.

1. Remove the right hand crankcase cover as shown on page 9-3 of the workshop manual.
2. Remove the oil filter cap, clutch lifter plate, clutch springs and clutch centre as shown on pages 9-4 and 9-5 of the workshop manual.
3. Remove and discard the outer friction disc and in the following order, install the new friction disc and judder spring as shown below. Be sure to install the judder spring so that the white paint mark faces towards the outside. There is an illustration and photo below to help identify the white paint mark and direction of the judder spring.
4. Install the judder spring seat and reassemble the clutch assembly, oil filter cap and right hand crankcase cover as instructed on pages 9-7 to 9-12 of the workshop manual.
